Information BULLETIN

Issue No: MG016B **Date:** 18th February 2017

- McMurdo SmartFind EPIRB – All Versions
- Kannad Marine EPIRB, Sport/Sport Pro/Sport Pro +

Top dome replacement

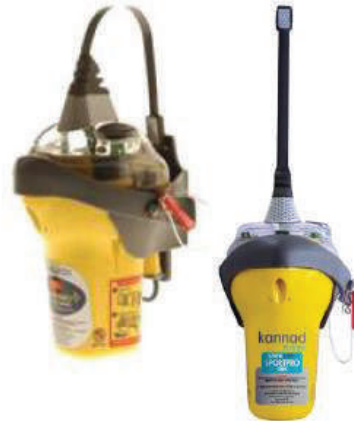
It has come to our attention that the top dome under certain circumstances may begin to show signs of localised craze cracking. Small cracks may appear to be radiating out from the three over moulded screw inserts.

1. Clearly, any cracking is undesirable and unsightly and our recommendation is that the EPIRB should be subject to rectification work at earliest opportunity.
2. Should you have any concern with regarding the condition of your EPIRB you are invited in the first instance to contact the McMurdo customer support team for advice.
3. If the EPIRB is in warranty period, complete an RMA application using the online form:-

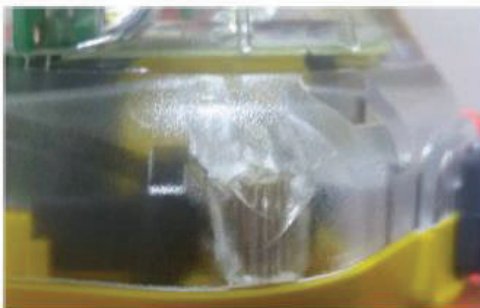
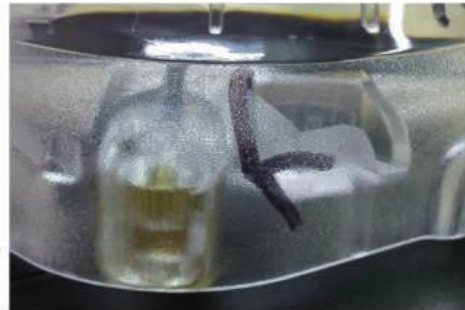
The cracking area is outside of the waterproof seal (main O ring seal) in a wet zone which is a self-draining cavity. As such, any cracking in this area will not compromise the waterproof body seal in anyway, or significantly weaken the overall integrity of the EPIRB.
