## Information BULLETIN

**Issue No:** MG016B **Date:** 18<sup>th</sup> February 2017

- McMURDO SmartFind EPIRB – All Versions
- Kannad Marine EPIRB, Sport/Sport Pro/Sport Pro +

### Top dome replacement

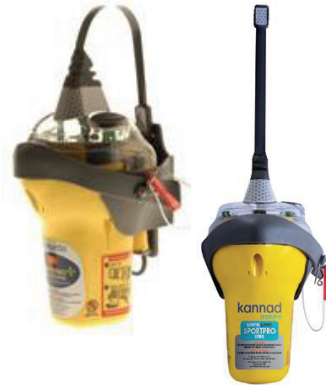
It has come to our attention that the top dome under certain circumstances may begin to show signs of localised craze cracking. Small cracks may appear to be radiating out from the three over moulded screw inserts.

1. Clearly, any cracking is undesirable and unsightly and our recommendation is that the EPIRB should be subject to rectification work at earliest opportunity.
2. Should you have any concern with regarding the condition of your EPIRB you are invited in the first instance to contact the McMURDO customer support team for advice.
3. If the EPIRB is in warranty period, complete an RMA application using the online form:-

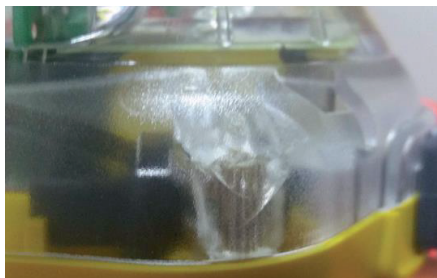
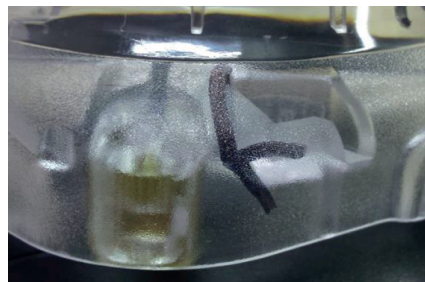
The cracking area is outside of the waterproof seal (main O ring seal) in a wet zone which is a self-draining cavity. As such, any cracking in this area will not compromise the waterproof body seal in anyway, or significantly weaken the overall integrity of the EPIRB.

Although the dome cracking is superficial and won't impact on operational effectiveness of the beacon, customer safety and confidence in McMURDO's products is our primary concern. If you need further information regarding the issue or rectification process, please contact our customer service team for further advice.
