*** DE. BSH. Marktüberwachung. Hinweis für Ölgehaltsmessgeräte**

Information from USCG regarding oil-content meters type “BilgMon 488”

MARINE SAFETY LESSONS LEARNED

Avoid delays and keep your ship on schedule! **Does your BilgMon 488 Bilge Alarm / Oil Content Meter operate properly?**

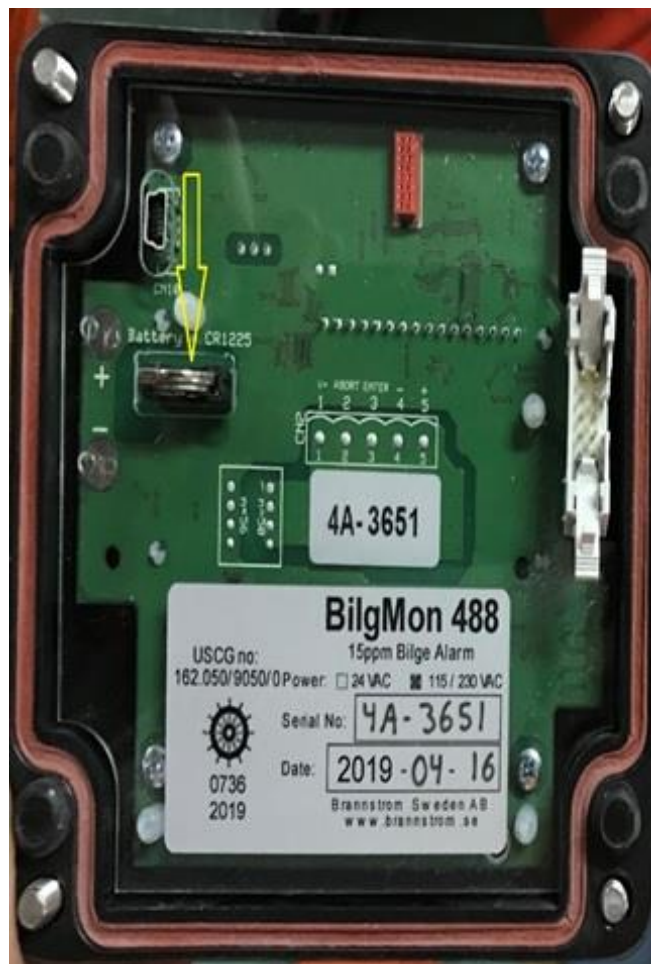
The newer model BilgMon 488 is equipped with a replaceable battery shown on the right below the yellow arrow. As a result, when the battery weakens the unit display will read "Batterylow: 0.5V Replace battery." The battery can then be safely removed because it utilizes a capacitor that ensures enough energy to maintain the stored data for several hours. [Click here for the applicable manual.](#)²

To identify what model you may have note that the older type of master unit has serial numbers starting with "A," "AE," "BFA," and "EDA." The newer type of master unit has serial numbers starting with "4A," "4AE," "4BFA," and "4EDA." [Click here for information on how to locate these numbers.](#)³
